Inspection Report

246 Main Street Miller Place New York 11764

VINNYS HOME INSPECTIONS

| Date: 8/7/2020 | Time: 03:00 PM | Report ID: Sample #2 |

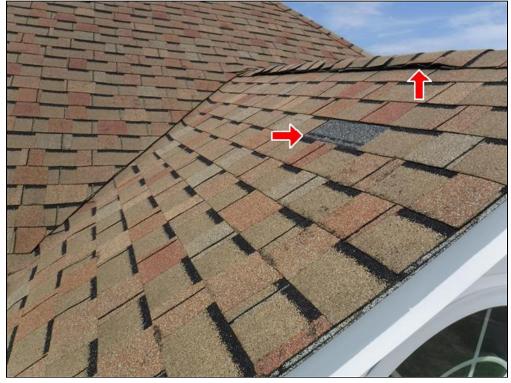
1.0 Item 2(Picture)

246 Main Street Page 4 of 112 **1.0** Multiple shingles were missing or appear to be lifting. Recommend a full evaluation by a licensed roofer to fully evaluate for repairs - removal to prevent water intrusion into home.

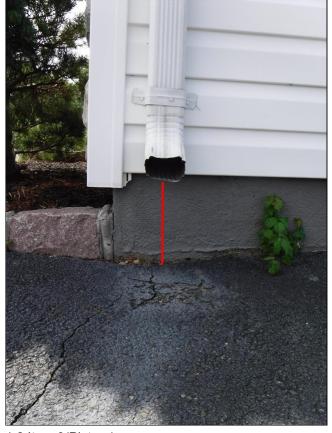
1.2 Item 3(Picture)

(2) Found downspouts, extensions, elbows, and diverters missing on multiple gutter downspouts. Downspouts, elbows and diverters are important to deliver water away from the foundation to avoid any water or moisture issues to foundation or basement. Recommend repairs by a qualified professional.

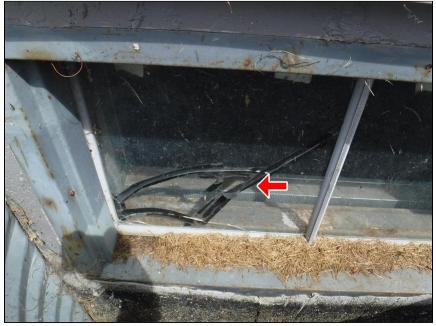
(2) Basement window glass is cracked . Needs to be repaired by a qualified professional.

2.1 Item 5(Picture) basement window broken

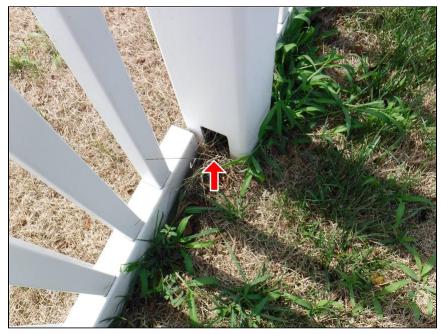
2.3 (1) Loose railing detached from post at rear left side of home needs to be repaired by a qualified professional.

2.3 Item 1(Picture) left side backyard

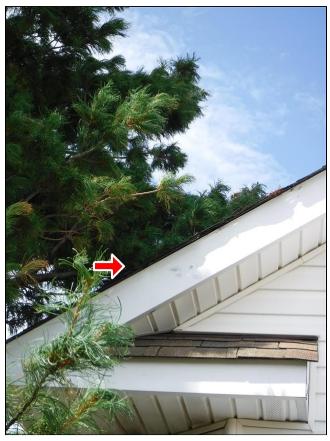
(2) The tree limbs that are in contact with roof or hanging near roof should be trimmed. Tree limbs that are in contact with the roof can affect the life expectancy of the roof covering.

2.5 Item 3(Picture) Branches on roof

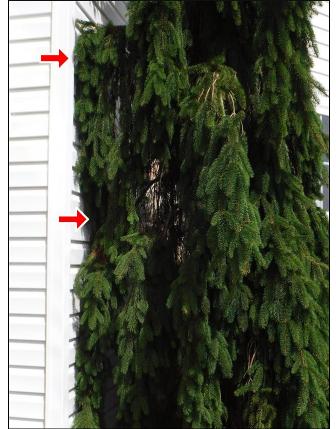
2.5 Item 4(Picture)

(3) Any vegetation should be a minimum of 12" away from home to prevent moisture buildup or giving insects like carpenter ants or termites easy access to home.

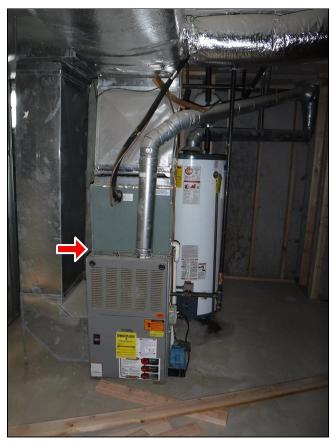
4.0 Gas was not on at time of inspection making it not possible to determine if heat system is working properly. Heating system needs to be fully evaluated by a licensed hvac contractor when gas is turned back on. This Weatherking combo heat system also provides cooling and was manufactured in 2005. It has a life expectancy of around 20 years but can last longer with proper care and maintenance.

4.0 Item 1(Picture) heating system

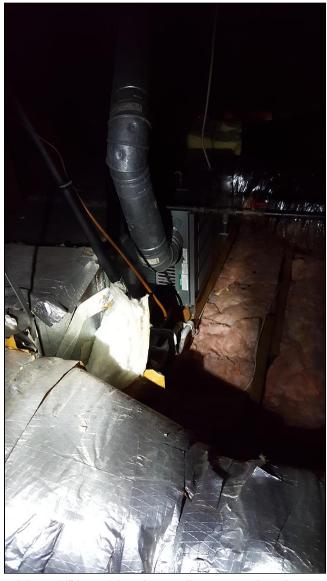
4.0 Item 3(Picture) heating cooling system in attic

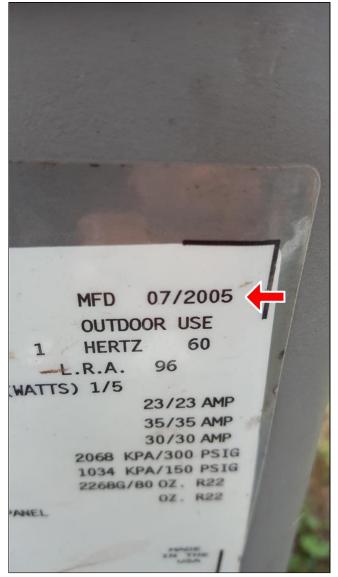
4.9 Item 2(Picture)

4.9 The air conditioning was working at time of inspection. The air condensers were manufactured in 2005 and have a life expectancy of 15 to 20 years.

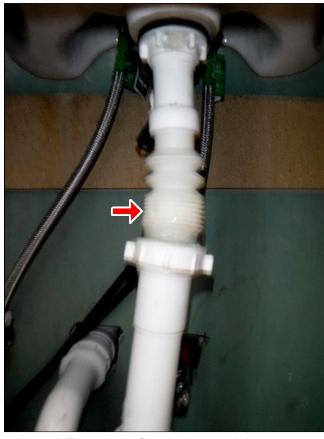
(2) Flexible tailpipes and drains are incorrect and made of accordion plastic. It can catch debris which is supposed to flow down the drain smoothly. Recommend repair by a licensed plumber.

5.0 Item 3(Picture) 1st floor bathroom sink trap

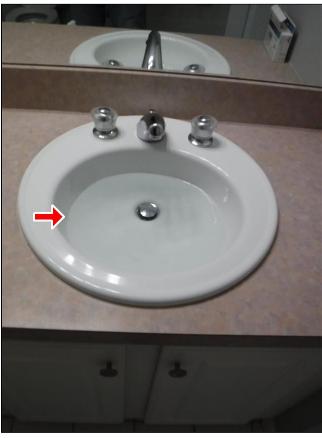
(6) Bathroom sink on 2nd floor was draining very slowly. Needs to be repaired by a licensed plumber.

5.0 Item 8(Picture) 2nd floor bathroom sink

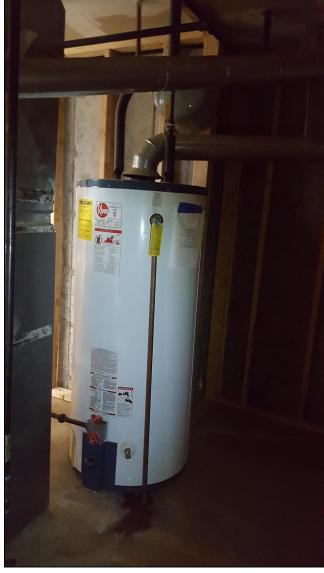
5.3 Item 2(Picture)

- 5.2 Water main shutoff is located in basement.
- **5.3** Hot water heater was not working at time of inspection due to gas being off. The water heater was manufactured in 2004. Hot water heaters have a life expectancy of 8 to 12 years. Recommend having hot water heater replaced by a licensed plumber as it has reached its life expectancy.

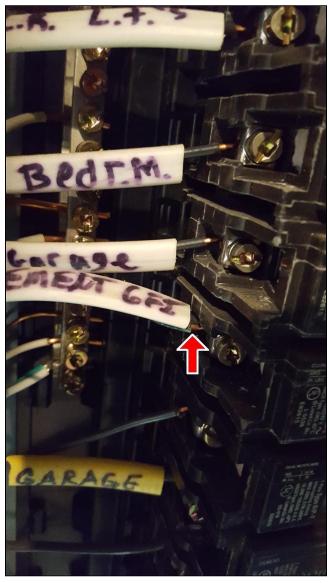
6.1 (1) Found a double tapped breaker at electrical panel. A double tapped breaker is when two wires share one breaker that is designed for one wire. This can cause overloading causing the breaker to overheat. Recommend a full evaluation by a licensed electrician as this can be a safety issue.

6.1 Item 1(Picture) Double tapped breaker

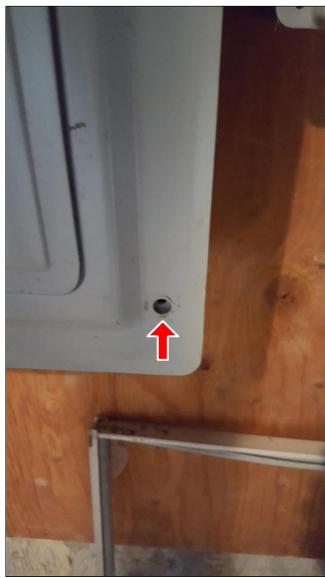
6.1 Item 3(Picture)

(2) Screws were missing on electrical panel. Needs to be corrected by a licensed electrician.

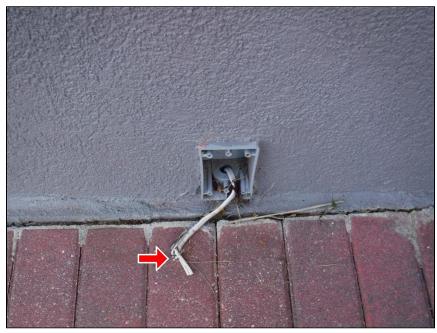
6.3 (1) At time of inspection found open electrical wiring in basement and exterior of home which is a safety issue. Any open wiring should be concealed in a junction box or have proper plates and covers installed. Recommend repairs be made by a licensed electrician.

6.3 Item 1(Picture) exterior

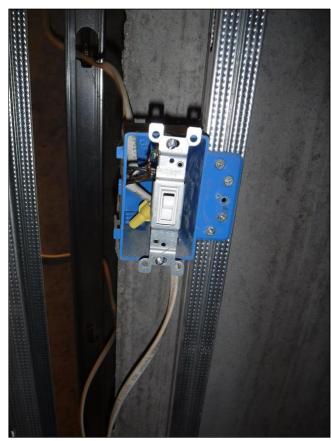
6.3 Item 3(Picture) basement

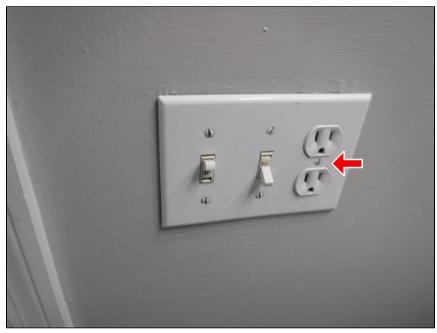
6.4 Found outlets throughout home that are not gfci protected or not working correctly. Gfci outlets should be present in bathrooms,kitchens,garages and any outdoor space. Recommend full replacement by a licensed electrician as this is a safety issue.

6.4 Item 1(Picture) 1st floor bathroom

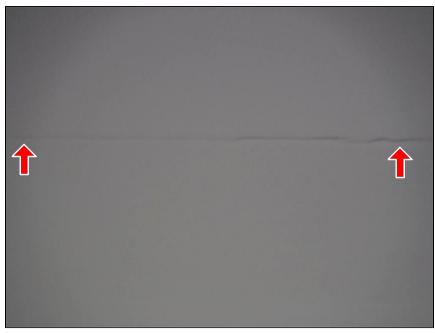
246 Main Street Page 64 of 112 **8.0** Found multiple areas on ceiling where seems are showing and appear to be cosmetic. Needs to be spackled and repaired by a qualified professional.

8.0 Item 1(Picture) seam showing on ceiling

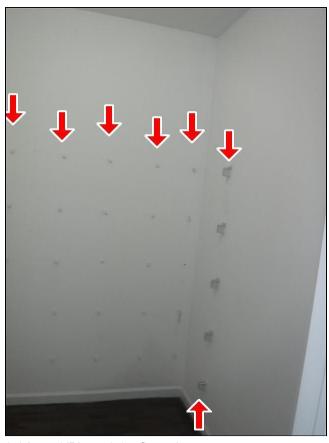
8.1 FYI, found multiple fastenings for shelves in 1st floor closet that might need to be removed and patched by a qualified professional.

8.1 Item 1(Picture) 1st floor closet

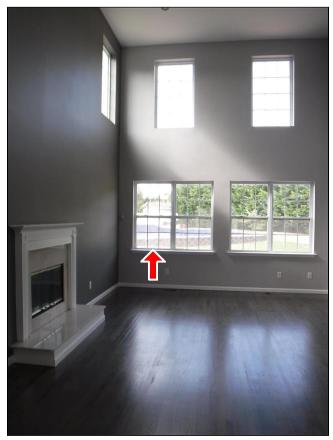
(2) Missing glass on double pane window needs to be repaired by a licensed contractor.

8.2 Item 2(Picture) Broken glass

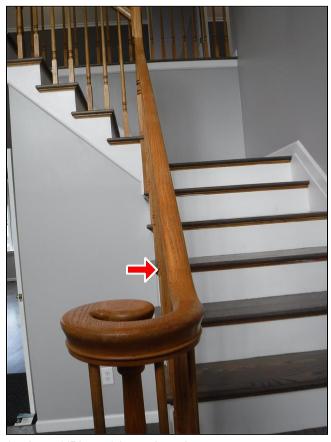
8.4 Found loose handrail leading to 2nd floor that should be repaired by a qualified professional as this is a safety issue.

8.4 Item 1(Picture) loose bannister

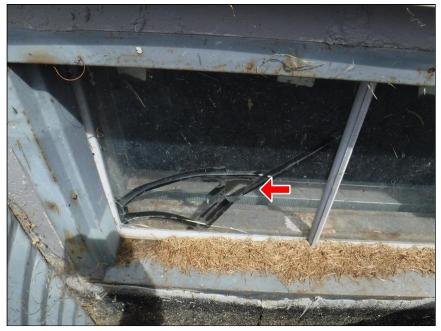
(2) Basement window glass is cracked . Needs to be repaired by a qualified professional.

2.1 Item 5(Picture) basement window broken

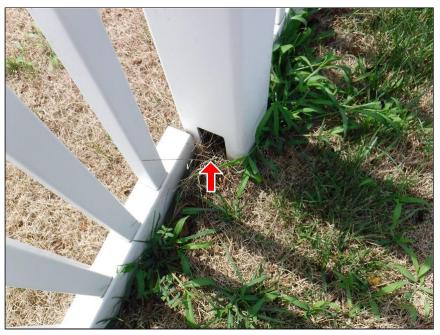
(1) Loose railing detached from post at rear left side of home needs to be repaired by a qualified professional.

2.3 Item 1(Picture) left side backyard

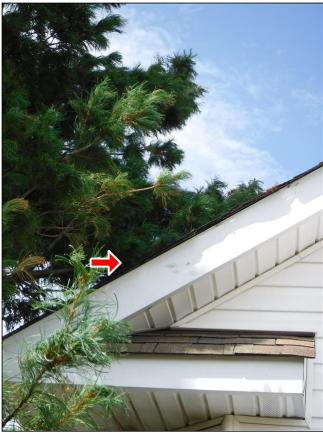
2.5 Item 3(Picture) Branches on roof

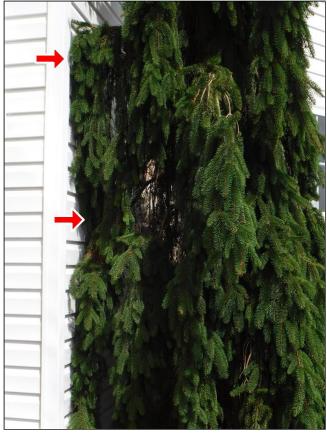
2.5 Item 4(Picture)

(3) Any vegetation should be a minimum of 12" away from home to prevent moisture buildup or giving insects like carpenter ants or termites easy access to home.

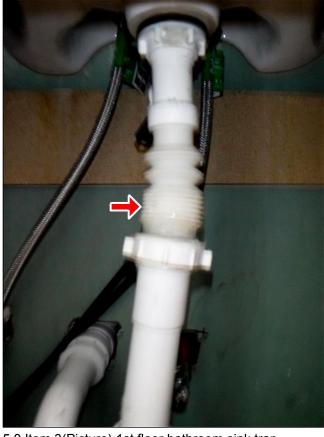
(2) Flexible tailpipes and drains are incorrect and made of accordion plastic. It can catch debris which is supposed to flow down the drain smoothly. Recommend repair by a licensed plumber.

5.0 Item 3(Picture) 1st floor bathroom sink trap

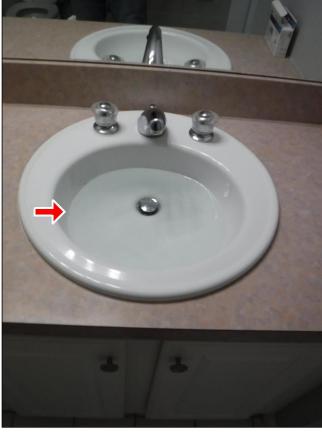
5.0 Item 8(Picture) 2nd floor bathroom sink

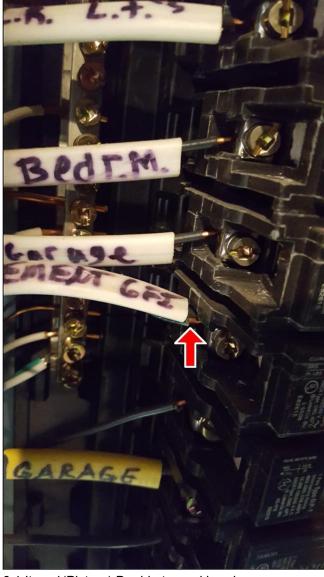
6.1 Item 1(Picture) Double tapped breaker

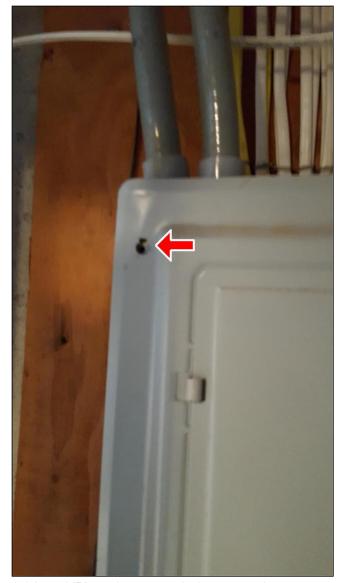
(2) Screws were missing on electrical panel. Needs to be corrected by a licensed electrician.

6.1 Item 2(Picture) screws missing at panel

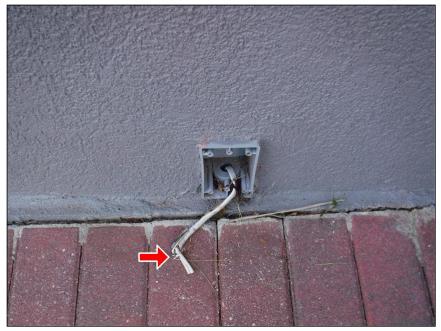
6.3 Item 1(Picture) exterior

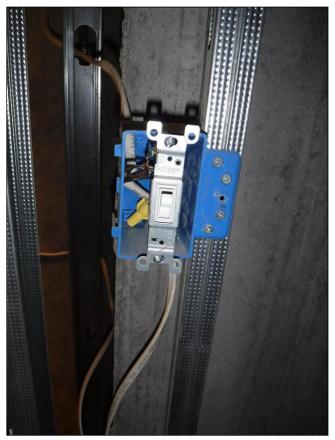
6.3 Item 3(Picture) basement

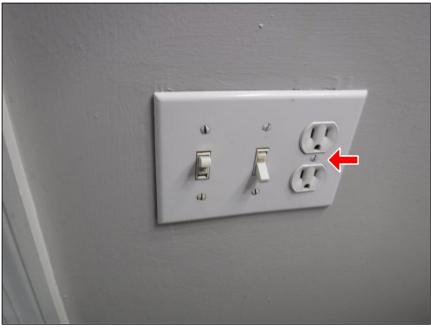
6.4 Item 1(Picture) 1st floor bathroom

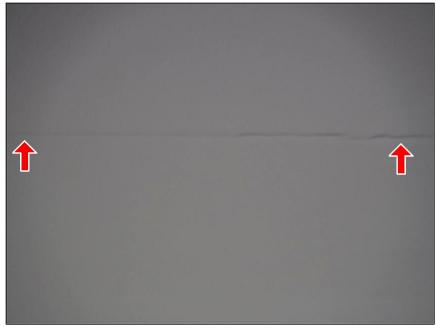
8.0 Item 1(Picture) seam showing on ceiling

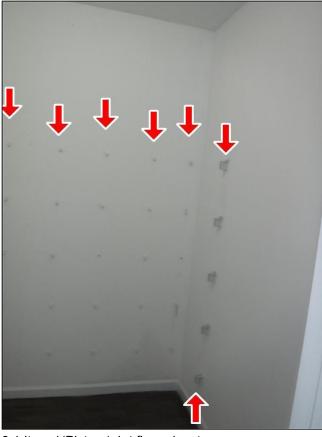
8.1 Item 1(Picture) 1st floor closet

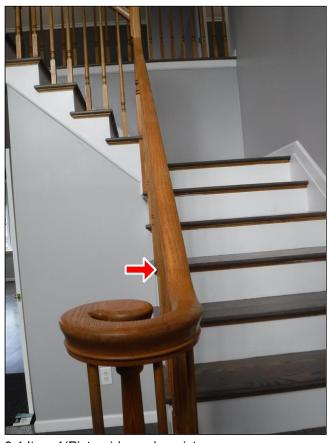
Found loose handrail leading to 2nd floor that should be repaired by a qualified professional as this is a safety issue.

8.4 Item 1(Picture) loose bannister
