Inspection Report

Property Address:
274 22nd Street
Brooklyn New York 11215

VINNYS HOME INSPECTIONS

Date: 9/24/2020	Time: 10:30 AM	Report ID: Sample Condo Report
Property: 274 22nd Street Brooklyn New York 11215	Customer: Jane Doe	Real Estate Professional:

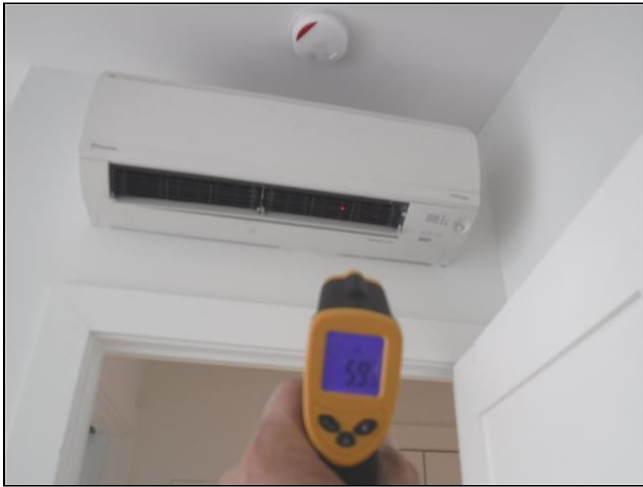
3.6 Item 1(Picture)

3.6 Split unit systems that provide heating and cooling have a life expectancy of 10-15 years. Units were manufactured in 2018. The heating and cooling system was recently installed as per agent. Any paper work or warranties on units should be requested before closing. System was working at time of inspection,

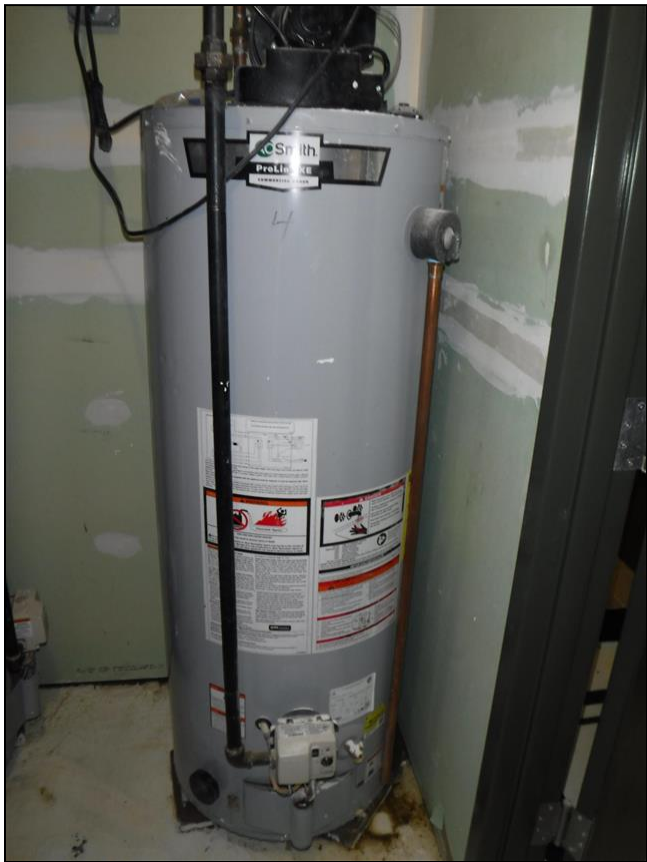
4.2 Item 1(Picture) hot water heater

4.2 (1) The life expectancy of a water heater is 8 - 12 years. The A O Smith water heater was manufactured in November of 2019.

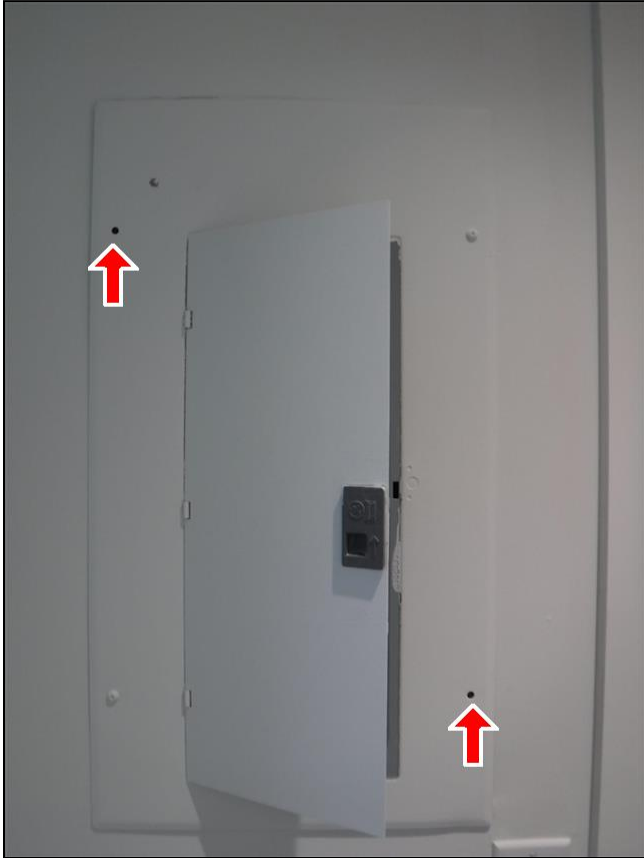
5.0 Item 1(Picture) sub panel in apartment

5.0 Screws were missing on electrical sub panel covers in apartment and at main electrical panel in basement. Needs to be corrected by a licensed electrician.

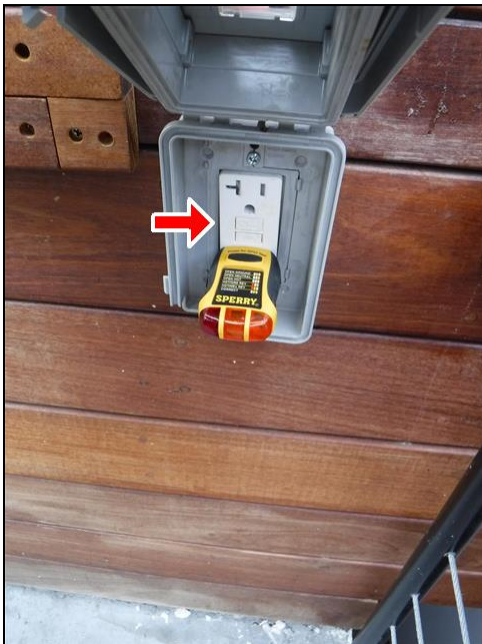
5.2 Item 1(Picture) front exterior of building

5.2 At time of inspection Gfci outlet next to front entrance of building and Gfci outlet located on balcony off master bedroom had no power. Needs to be repaired by a licensed electrician.

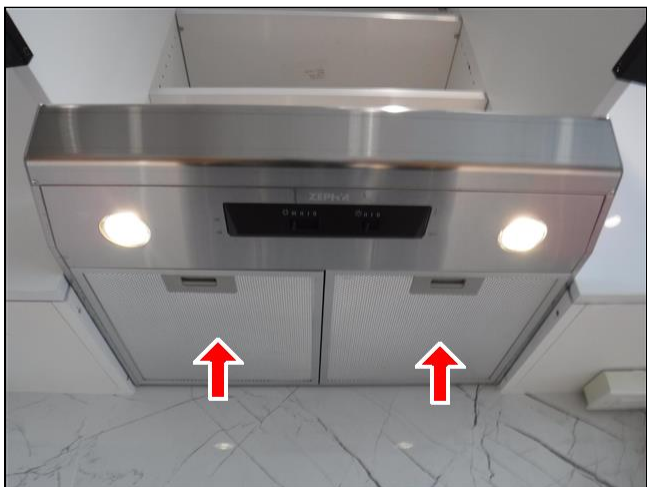
6.0 Item 1(Picture) kitchen exhaust

6.0 Try to maintain filters in kitchen exhaust to prevent any grease or heat buildup in kitchen.

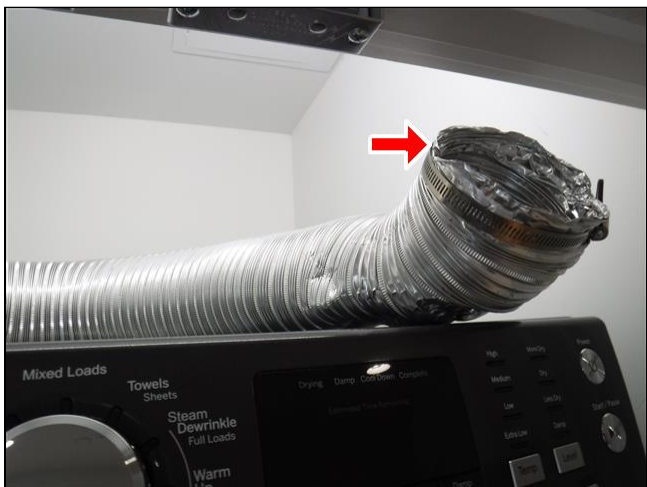
8.3 Item 1(Picture) Dryer flexible vent pipe

8.3 The dryer was recently purchased and needs to be hooked up. Needs to be properly installed by a qualified professional.

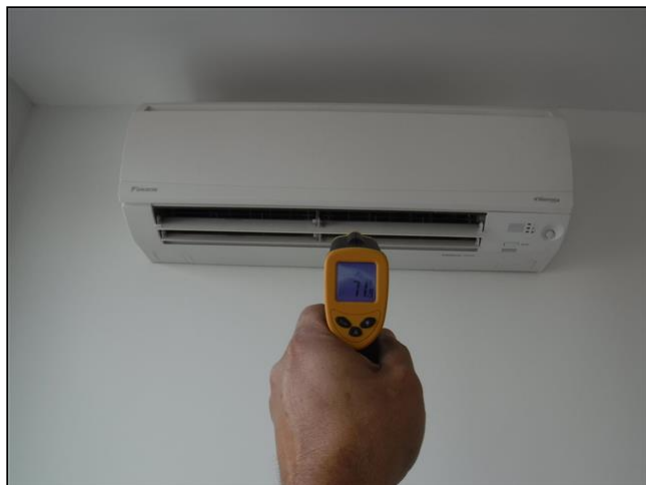
3.0 Item 1(Picture) heating register

Split unit systems that provide heating and cooling have a life expectancy of 10-15 years. Units were manufactured in 2018. The heating and cooling system was recently installed as per agent. Any paper work or warranties on units should be requested before closing. I was unable to get the heating system up to a adequate heat temperature. Have reviewed by a licensed heat contractor.

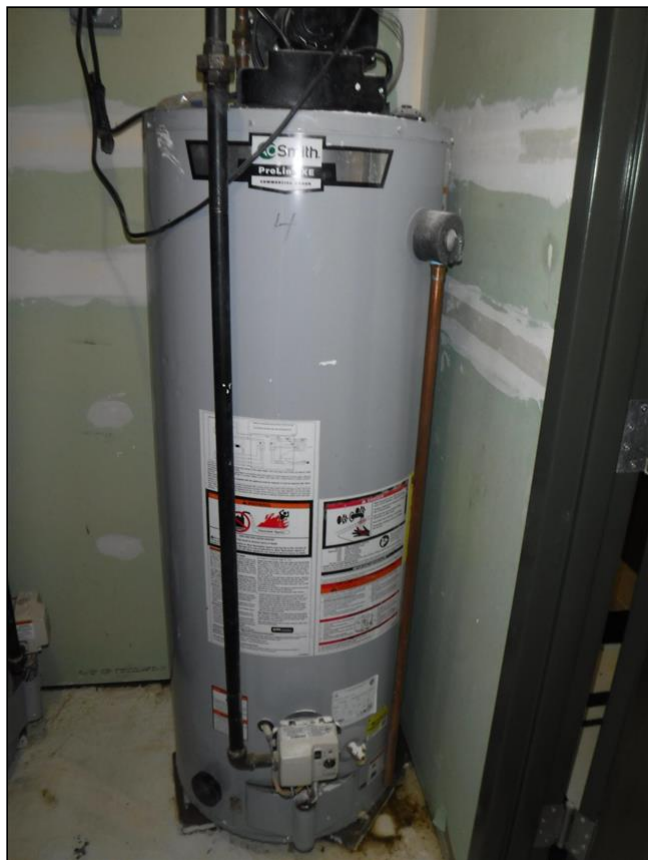
4.2 Item 1(Picture) hot water heater

(1) The life expectancy of a water heater is 8 - 12 years. The A O Smith water heater was manufactured in November of 2019.

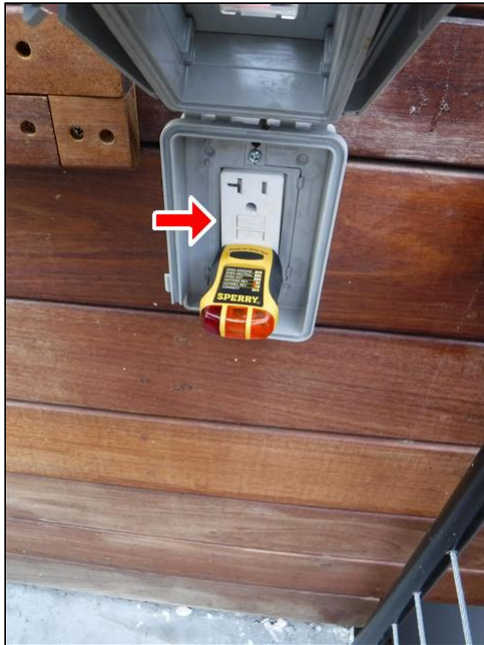
5.2 Item 1(Picture) front exterior of building

At time of inspection Gfci outlet next to front entrance of building and Gfci outlet located on balcony off master bedroom had no power. Needs to be repaired by a licensed electrician.

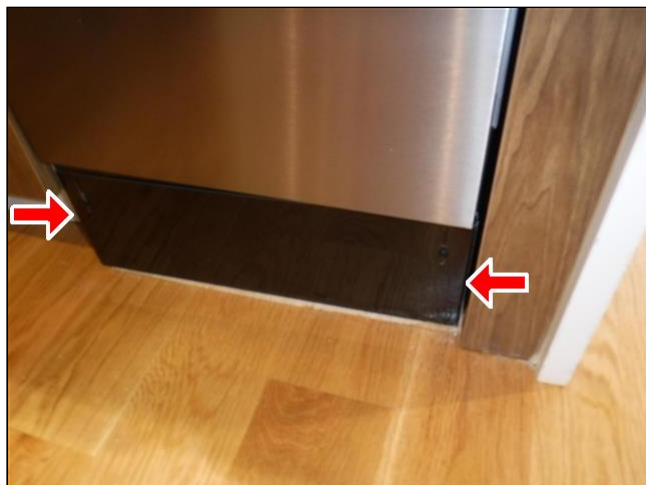
8.0 Item 1(Picture) Dishwasher

The kick plate on dishwasher is preventing the door from opening smoothly. Needs to be adjusted by a qualified person.

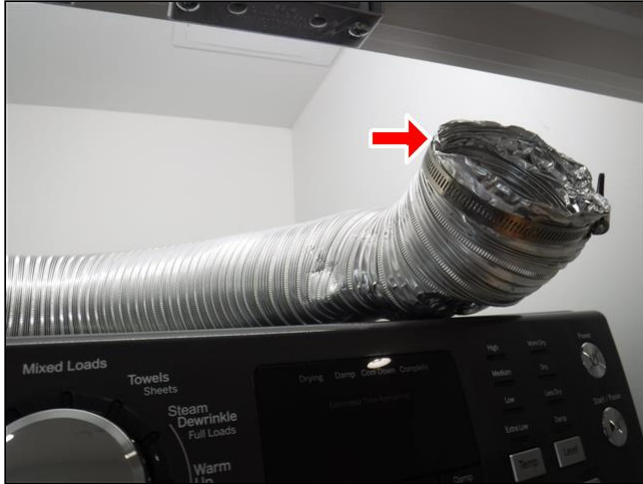
8.3 Item 1(Picture) Dryer flexible vent pipe

The dryer was recently purchased and needs to be hooked up. Needs to be properly installed by a qualified professional.
