Inspection Report

246 Main Street Miller Place New York 11764

VINNYS HOME INSPECTIONS

| Date: 8/7/2020 | Time: 03:00 PM | Report ID: Sample #2 |

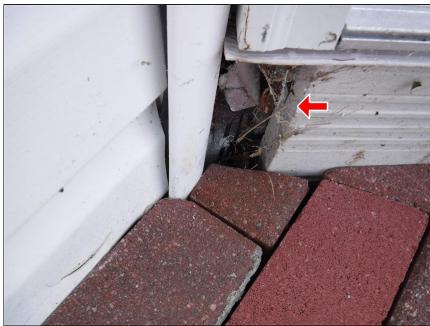
2.0 Item 4(Picture)

246 Main Street Page 10 of 112 **2.0** Multiple door mouldings at exterior of home were broken or had gaps. Needs to be repaired by a qualified professional to prevent any water intrusion or bug infestation.

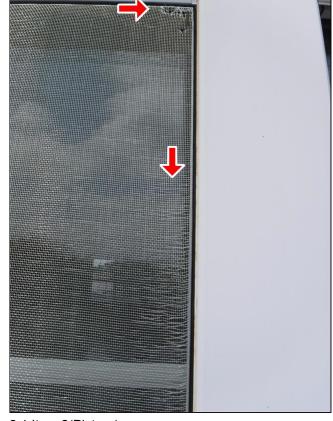
2.1 Item 2(Picture)

2.1 (1) Multiple window screens throughout home were torn. Need to be repaired by a qualified professional.

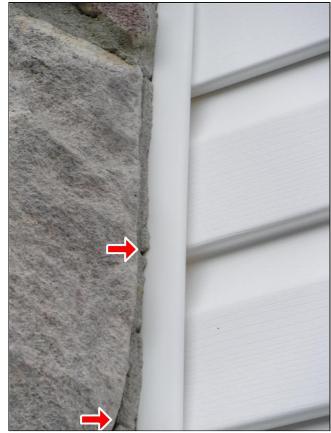
2.2 Item 5(Picture)

(2) Found multiple areas with missing mortar around joints. Recommend having them filled in by a licensed contractor to avoid any water intrusion or bug infestation into home.

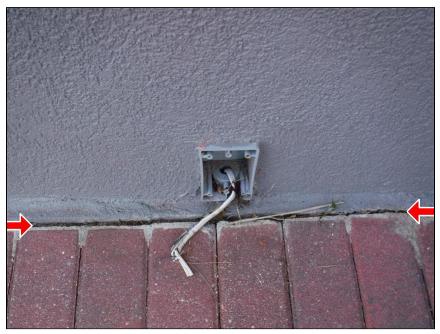
(3) Perimeter around foundation needs to be sealed to avoid any damage to foundation or water or moisture intrusion into basement.

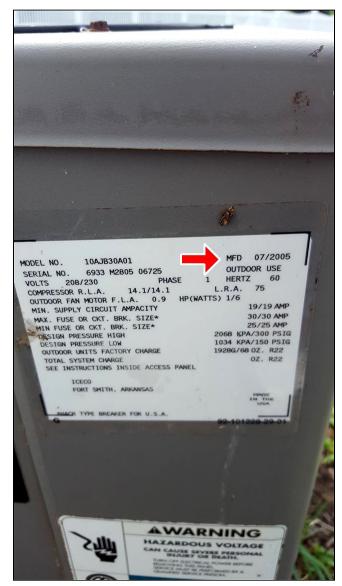
4.9 The air conditioning was working at time of inspection. The air condensers were manufactured in 2005 and have a life expectancy of 15 to 20 years.

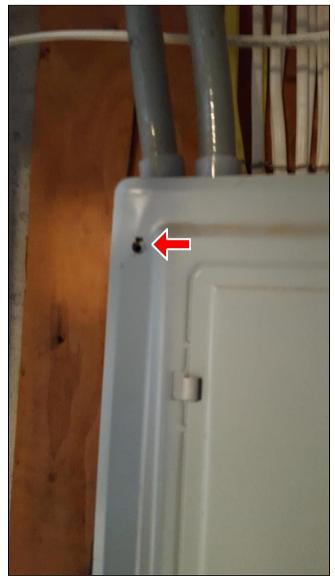
(2) Screws were missing on electrical panel. Needs to be corrected by a licensed electrician.

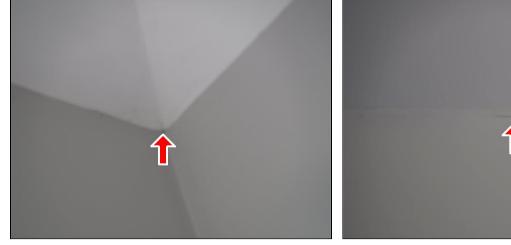
8.0 Item 1(Picture) seam showing on ceiling

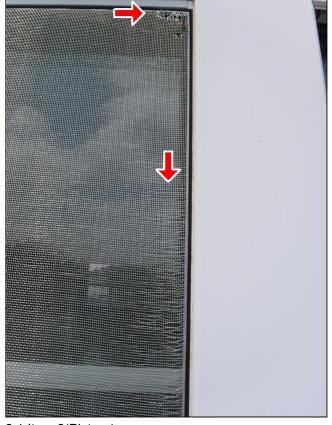
2.1 Item 2(Picture)

(1) Multiple window screens throughout home were torn. Need to be repaired by a qualified professional.

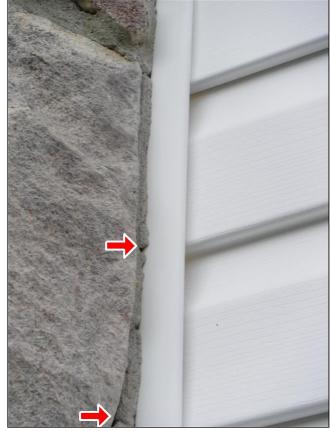
2.2 Item 5(Picture)

(2) Found multiple areas with missing mortar around joints. Recommend having them filled in by a licensed contractor to avoid any water intrusion or bug infestation into home.

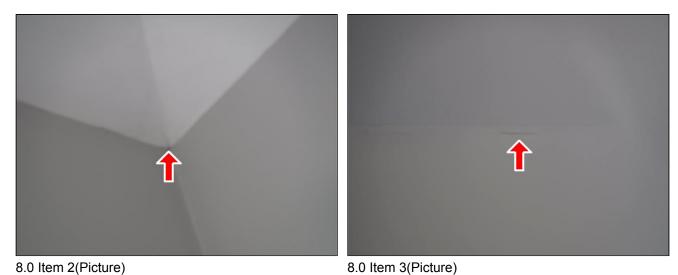
8.0 Item 1(Picture) seam showing on ceiling
